Cooks Beach Erosion and Mitigation Ecological Report 2019

Cooks Beach Erosion Mitigation Ecological Report 2019

Prepared for Thames Coromandel District
Council

May 2019

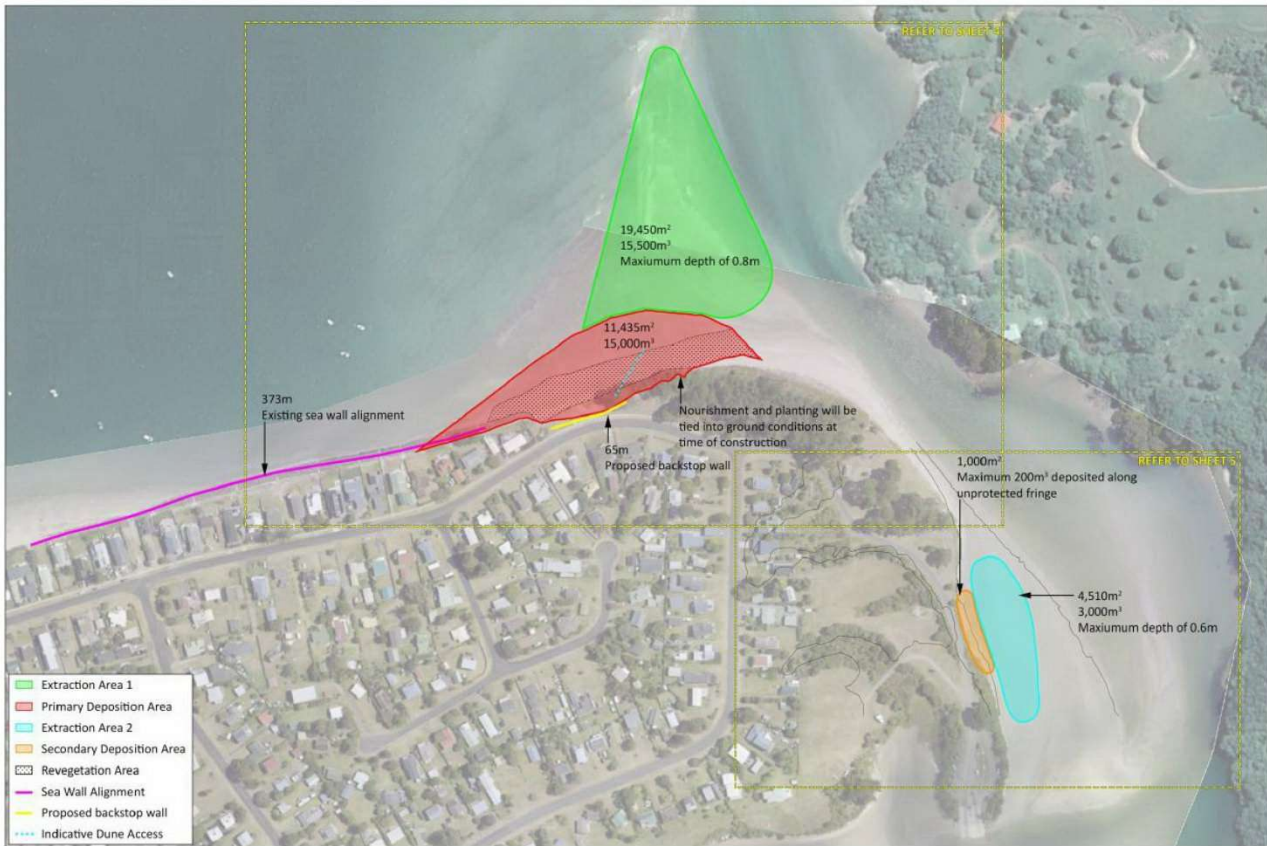
Figure 1: Plan of sand extraction and deposition areas

The proposed locations for sand removal and deposition (Figure 1) were predetermined by a 4Sight coastal processes scientist in consultation with an experienced 4Sight marine scientist. At the outset it was determined that, apart from a small sub channel (secondary blind channel) of the seaward delta, sand would only be removed from, and relocated to, mid to high shore zones. It is anticipated this approach would minimize, and probably avoid, risk to the more biodiverse areas of benthic macroinvertebrates including edible shellfish species, that are typically more prevalent in the mid to low shore.

The intertidal sandflat comprising sand extraction area two (Figure 1), is an elevated platform approximately 1 - 2 m above the tidal channel bed (Figure 9).

The delta sand extraction area one (Figure 1) is unconsolidated sand which is probably highly mobile. Other than around the low intertidal edges, the delta does not support an obvious benthic infaunal or epifaunal community. As for the estuary high shore areas, it is likely that a range of small crustacea and bivalves occur.

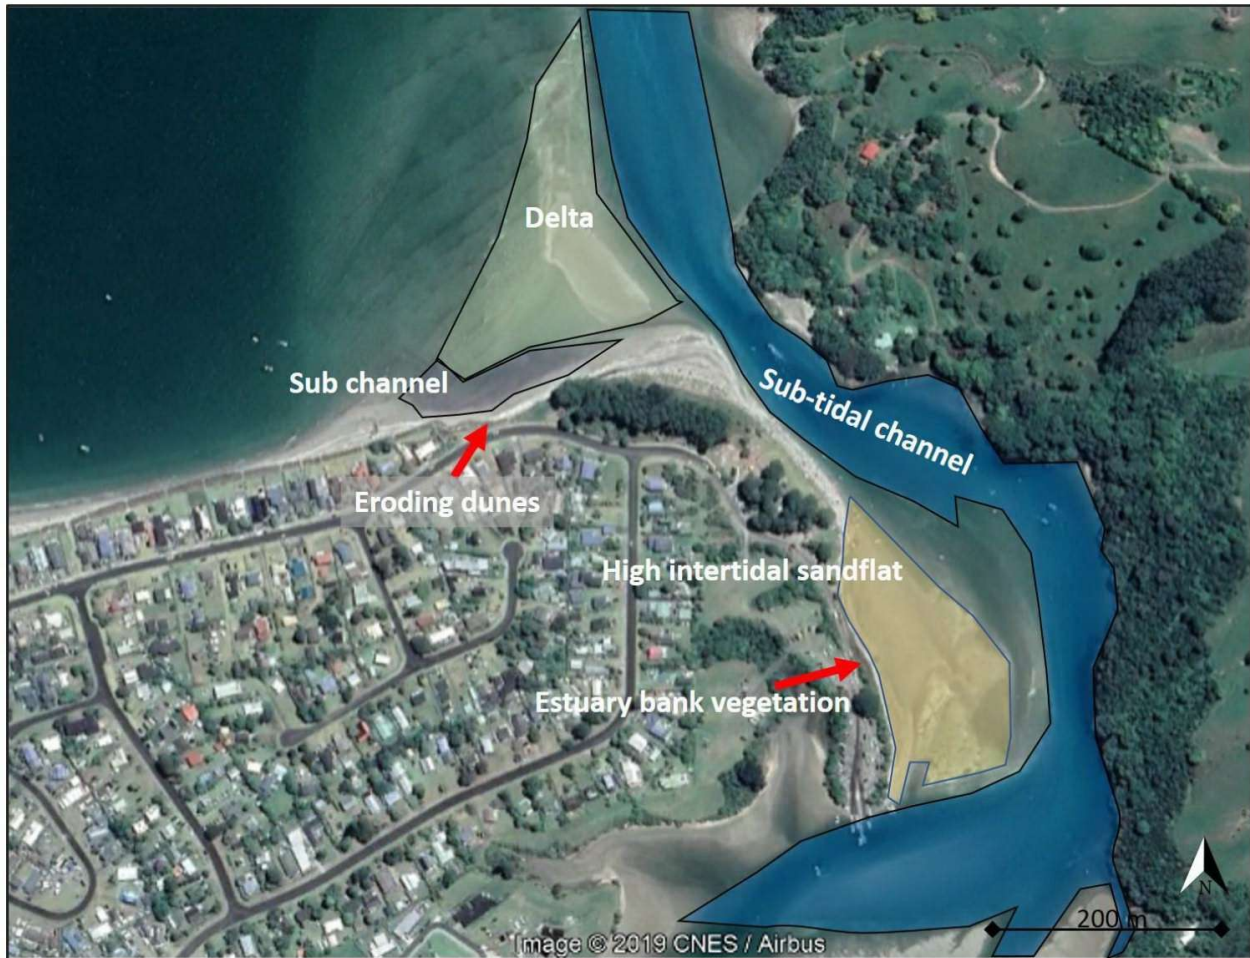
Figure 3: General plan of survey areas discussed in this report

A general plan of the survey areas is provided in Figure 3.

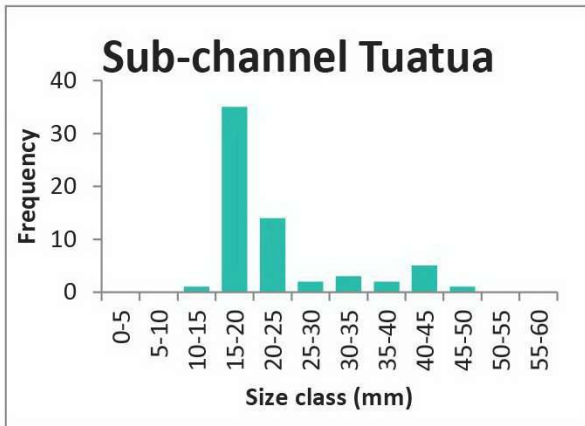
A total of 63 tuatua at an estimated density of 15.6/m² were sampled from within the Cooks Beach sub-channel. The average shellfish size was 22.97 ± 1.07 mm (SEM). Tuatua between 15-20 mm in size were the most frequent size class sampled. No individuals larger than 50 mm in size were recorded (Figure 4). The tuatua population consisted of small individuals at a low density. Near MLWS at the western (seaward) end of the channel, tuatua density increases and larger shellfish (> 40 mm) occur.

Figure 4: Size frequency distribution of tuatua sampled at the Cooks Beach sub-channel site

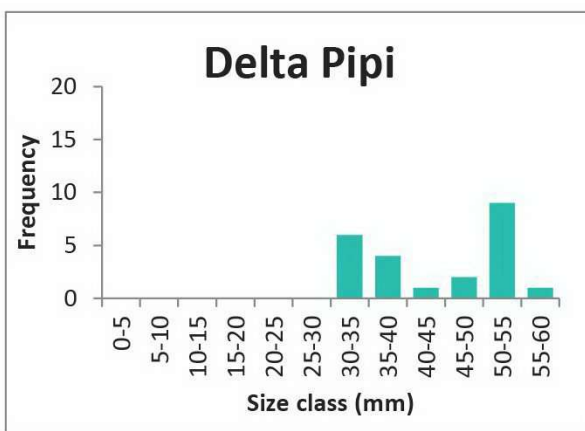
Pipi were recorded at this site, reflecting its still sheltered and predominantly estuarine aspect. Tuatua were not found at this location. 23 pipi at an estimated density of 5.7/m² were recorded from the delta transect. The average shellfish size was 44.41 ± 1.96 mm (SEM). Pipi between 50-55 mm in size were the most frequent size class sampled. No individuals larger than 60 mm in size were recorded (Figure 5).

Figure 5: Size frequency distribution of pipi sampled at the estuary delta site

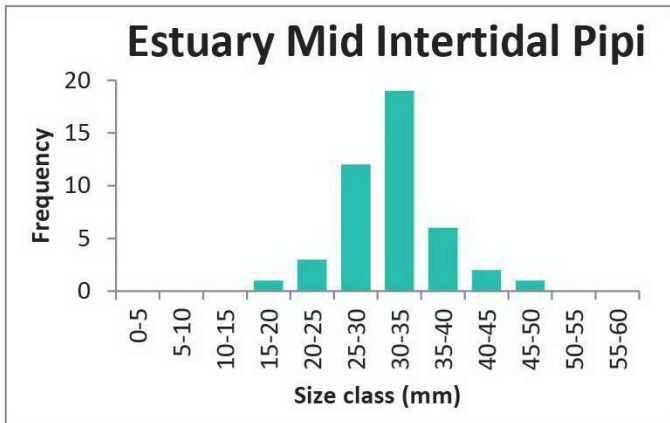
A total of 44 pipi at an estimated density of 165.9/m² were sampled along the estuary mid intertidal transect. The average shellfish size was 32.25 ± 0.84 mm (SEM). Pipi between 30-35 mm in size were the most frequent size class sampled. No individuals larger than 50 mm in size were recorded (Figure 5).

Figure 6: Size frequency distribution of pipi sampled at the estuary mid intertidal site

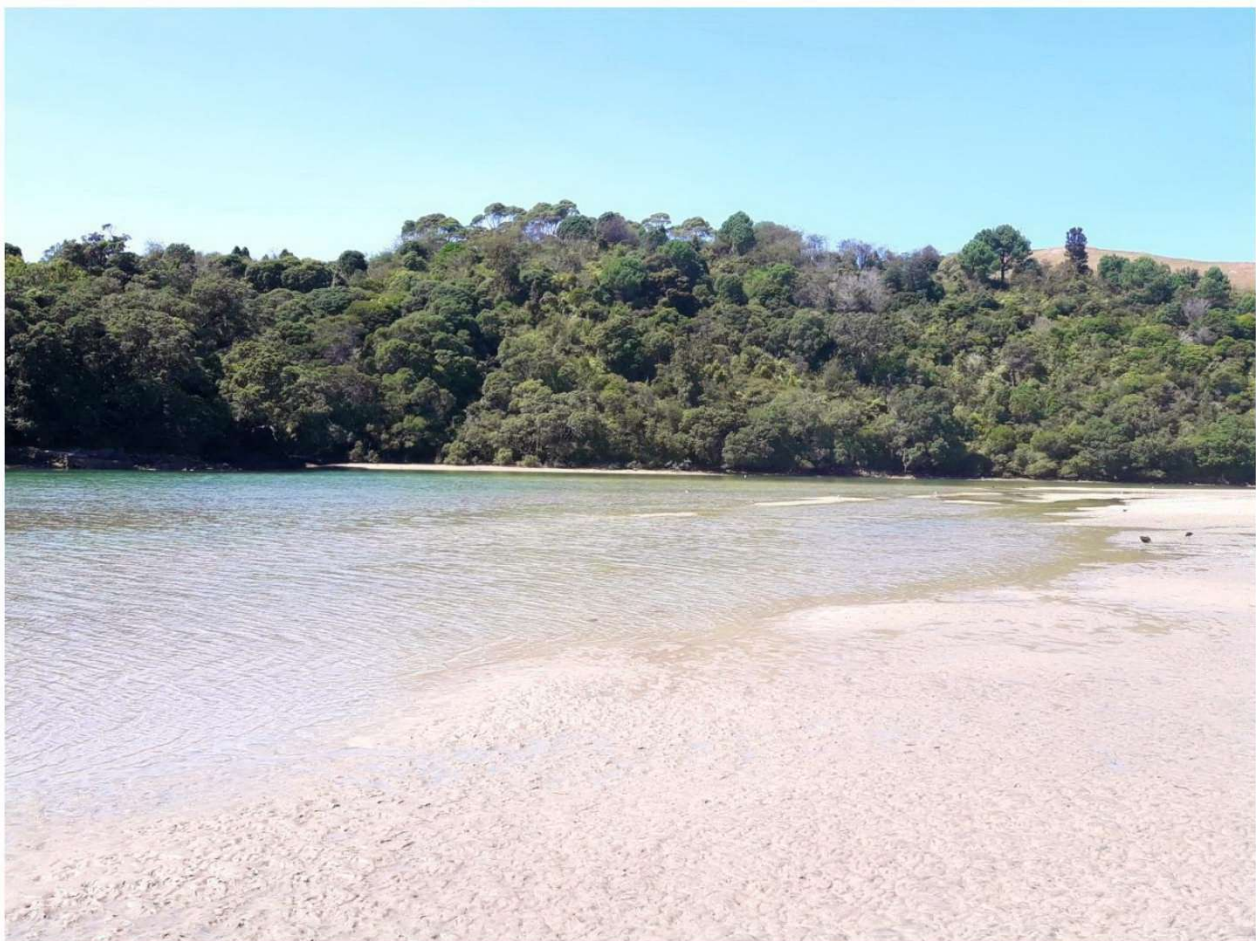
Figure 8: Section of Purangi river estuary showing a portion of the subtidal estuary channel bordered by mixed coastal broadleaf/pōhutukawa forest in the background.

Vegetation on the true right bank of the estuary was predominantly mixed coastal broadleaf/pōhutukawa forest (Figure 8).

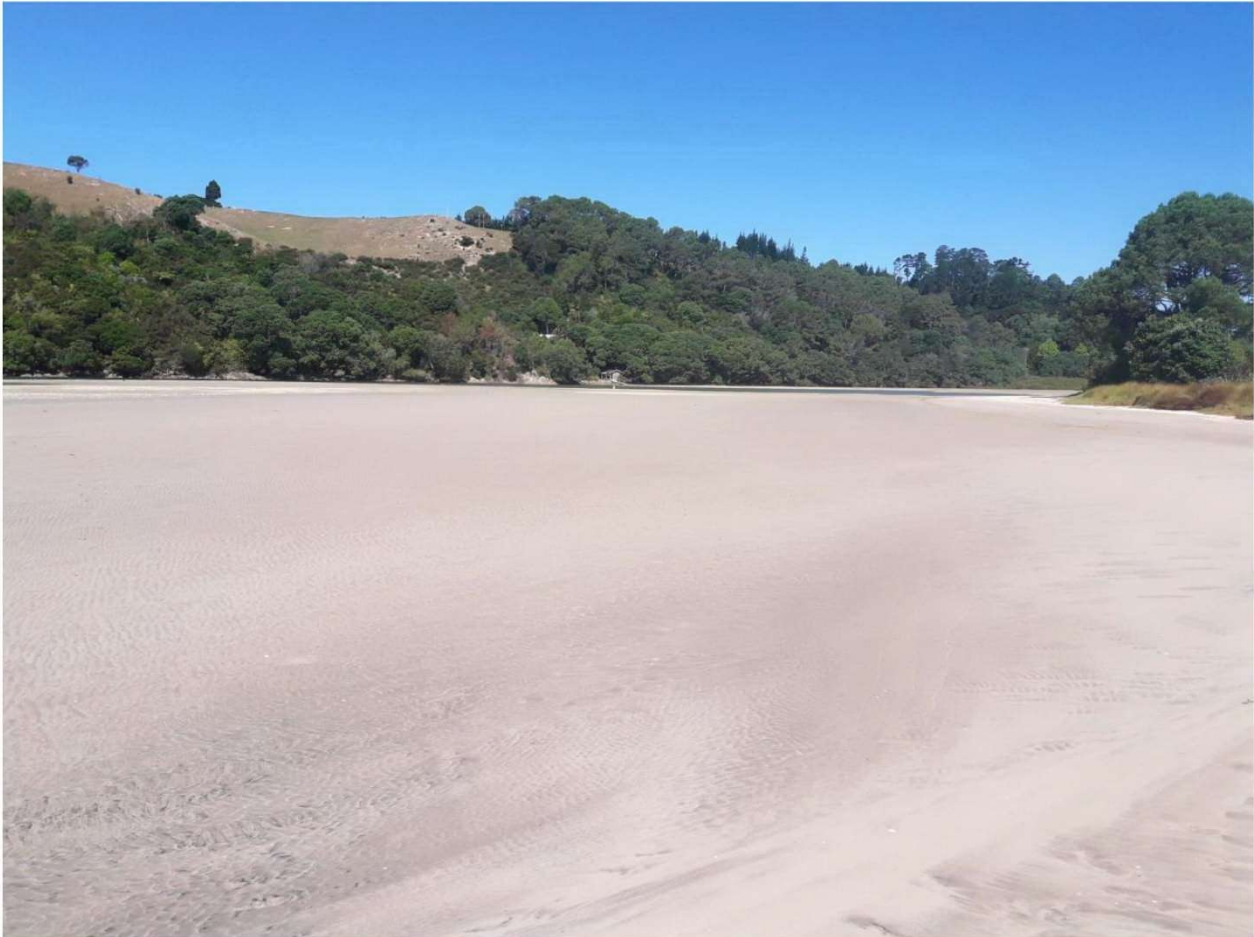
Brief visual inspections confirmed there is little biota in these zones. There is likely to be small crustacea such as amphipods and isopods.

Figure 9: High intertidal sandflat on the true left bank of Purangi river estuary. Looking upstream.

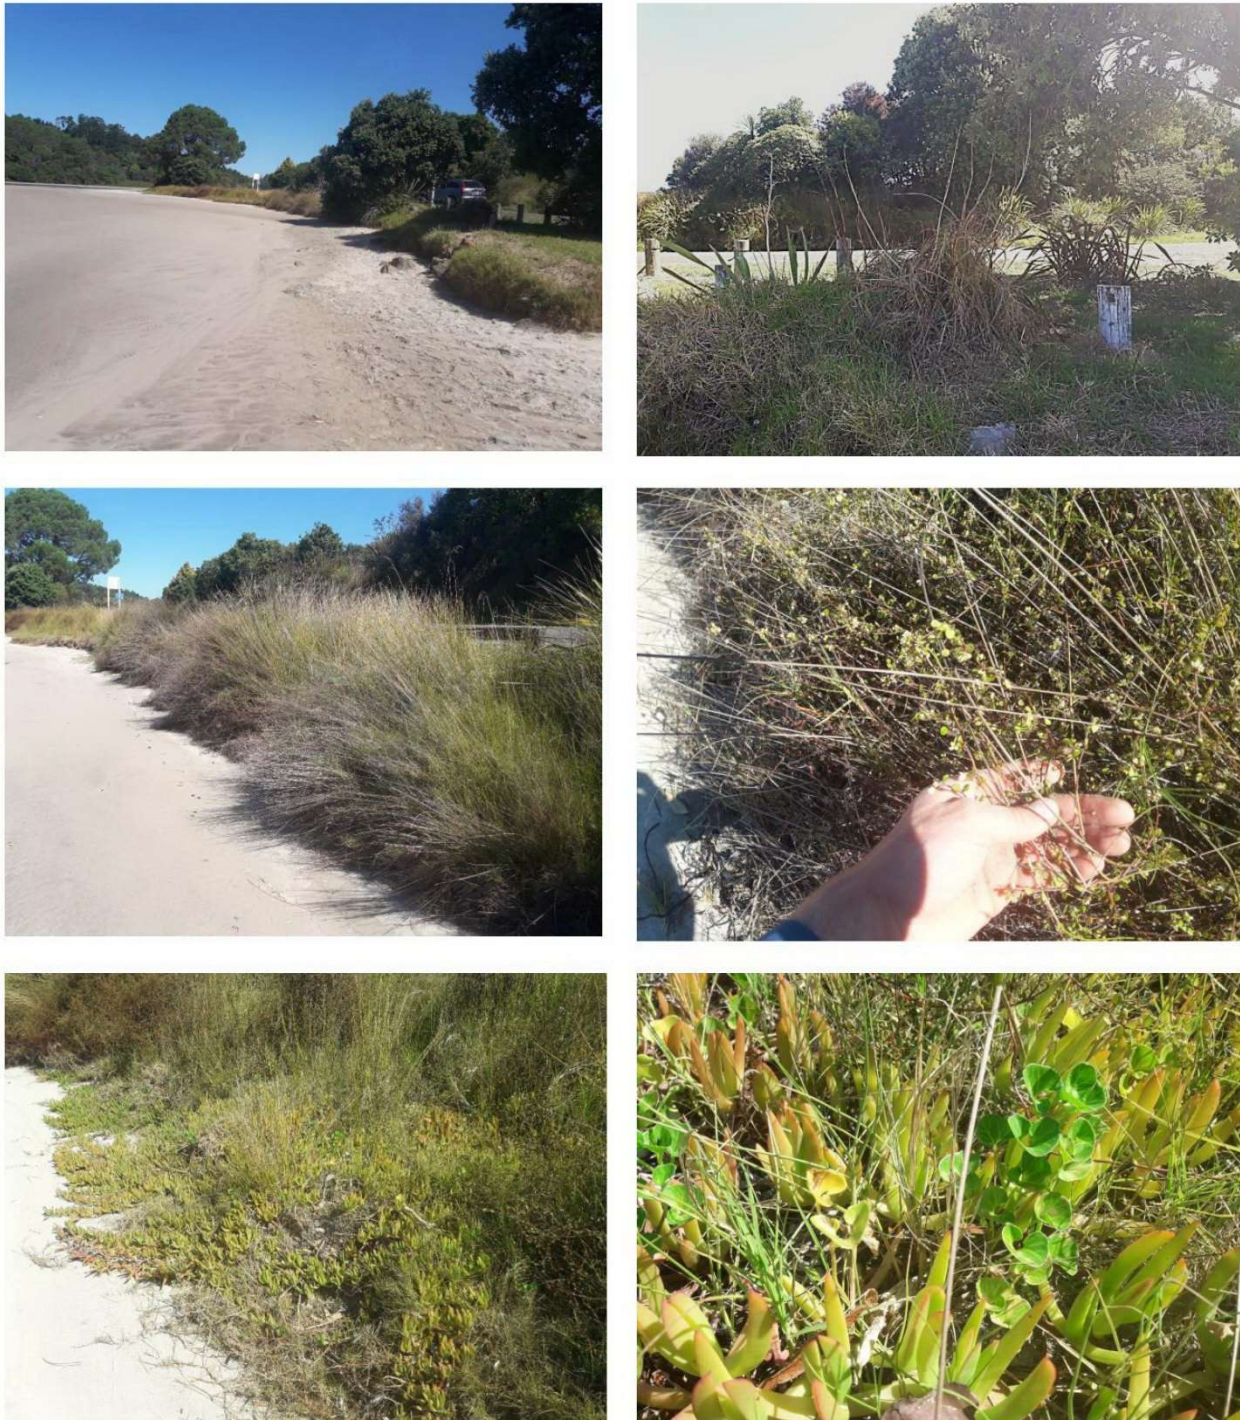
Figure 10: Typical vegetation occurring on the banks of the Purangi river estuary behind the proposed sand extraction area two.

The vegetation on the true left bank of the estuary, approximately two metres behind the proposed extraction area two, comprised a mixed native/exotic floral community. Wiwi, knobby club rush (*Ficinia nodosa*) and pohuehue (*Muehlenbeckia complexa* var. *complexa*) formed the dominant vegetation cover with rauparaha, shore bindweed (*Calystegia soldanella*) and pōhutukawa (*Metrosideros excelsa*) also present. A more degraded floral community occurred in several areas, with blackberry (*Rubus* sp.), kikuyu (*Cenchrus clandestinus*) and montbretia (*Crocasmia x crocosmiiiflora*) being the dominant species present (Figure 10).

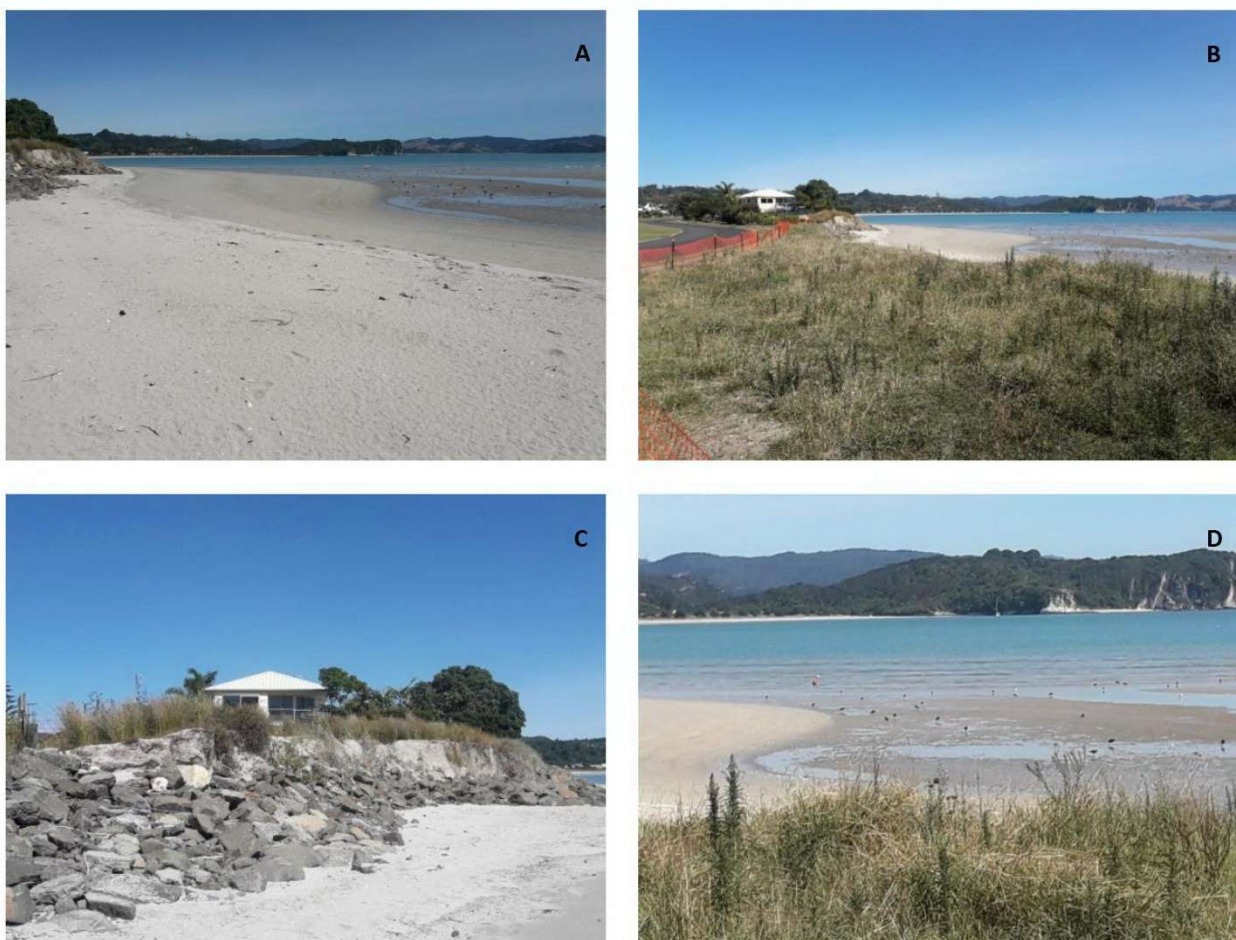
The proposed sand deposition area comprises the majority of the Cooks Beach sub-channel and the beach above this, extending inland to the eroded sand dunes bordering Captain Cook Rd (Figure 1). As noted, other than small crustacea, the beach area (Figure 11A) supports limited infauna.

Beyond the beach, the face of the eroded portion of dunes forms a vertical scarp predominantly devoid of vegetation. Behind this, on the more stable area above, a mixture of exotic herbaceous weeds and grasses are the only vegetation present (Figure 11B). To the south of the main erosion area a pine glade occupies the upper dune area. To the north of the main erosion area, prior to the private seawall, is a small portion of sand dune (~100m²) inhabited by native dune vegetation, including sand-binding species pingao (*Ficinia spiralis*) and spinifex (*Spinifex sericeus*) and pohuehue (*M. complexa var. complexa*) (Figure 11C).

Figure 11: Cooks Beach sand deposition and dune erosion area

At the low tidal zones of the delta, variable oystercatchers (*H. unicolor*) and red-billed gull (*C. novaehollandiae*) were observed foraging (Figures 11 a and d). Variable oystercatcher (*H. unicolor*) and white-fronted tern (*Sterna striata*) were also observed roosting/resting on the mid intertidal sandflats within sand extraction area one over the low tide period.
