Coastal Processes and Design Report

Cooks Beach

For Thames Coromandel District Council

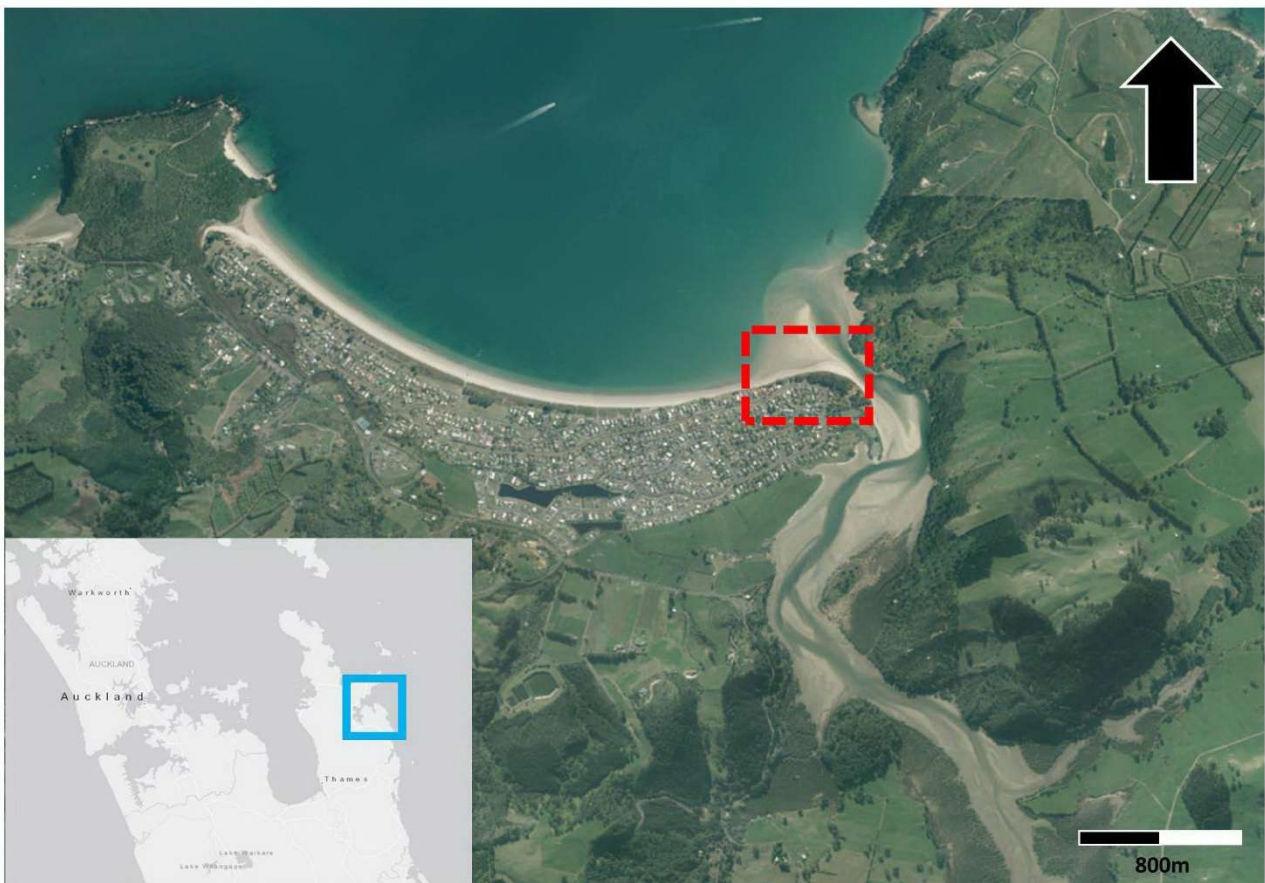
Figure 1: Location of the subject site with the red box indicating the area of concern.

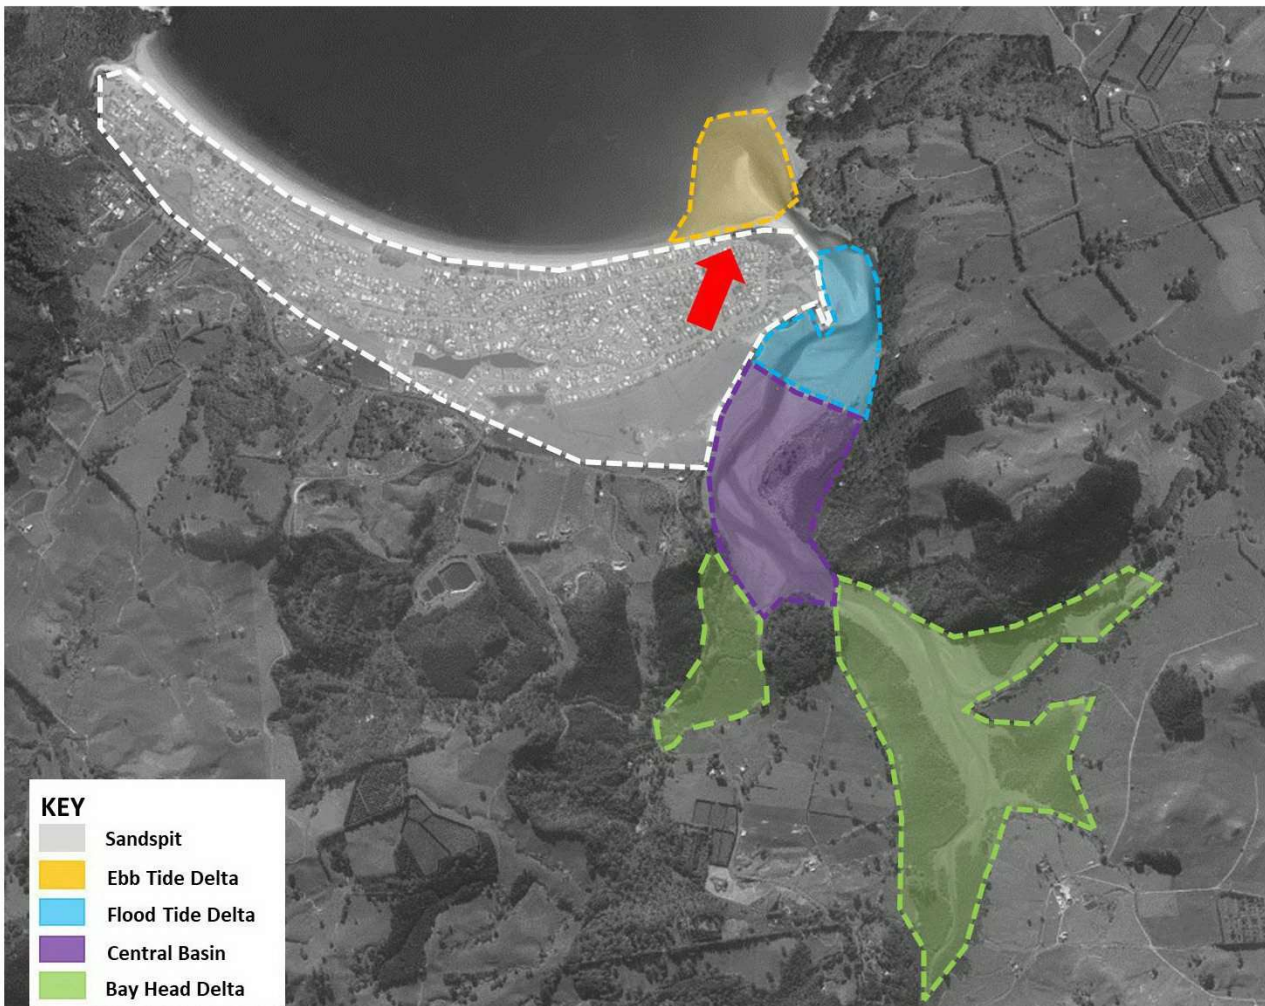
Figure 2: Geomorphic features of the Cooks Beach system.

The wider system is considered to be an example of a wave dominated estuarine system, characterised by the spit, ebb tide delta and flood tide delta features (**Figure 2**). It is considered that the central basin estuarine feature is poorly formed due to the limited accommodation space afforded by the small drowned river valley being occupied by the Purangi Estuary system.

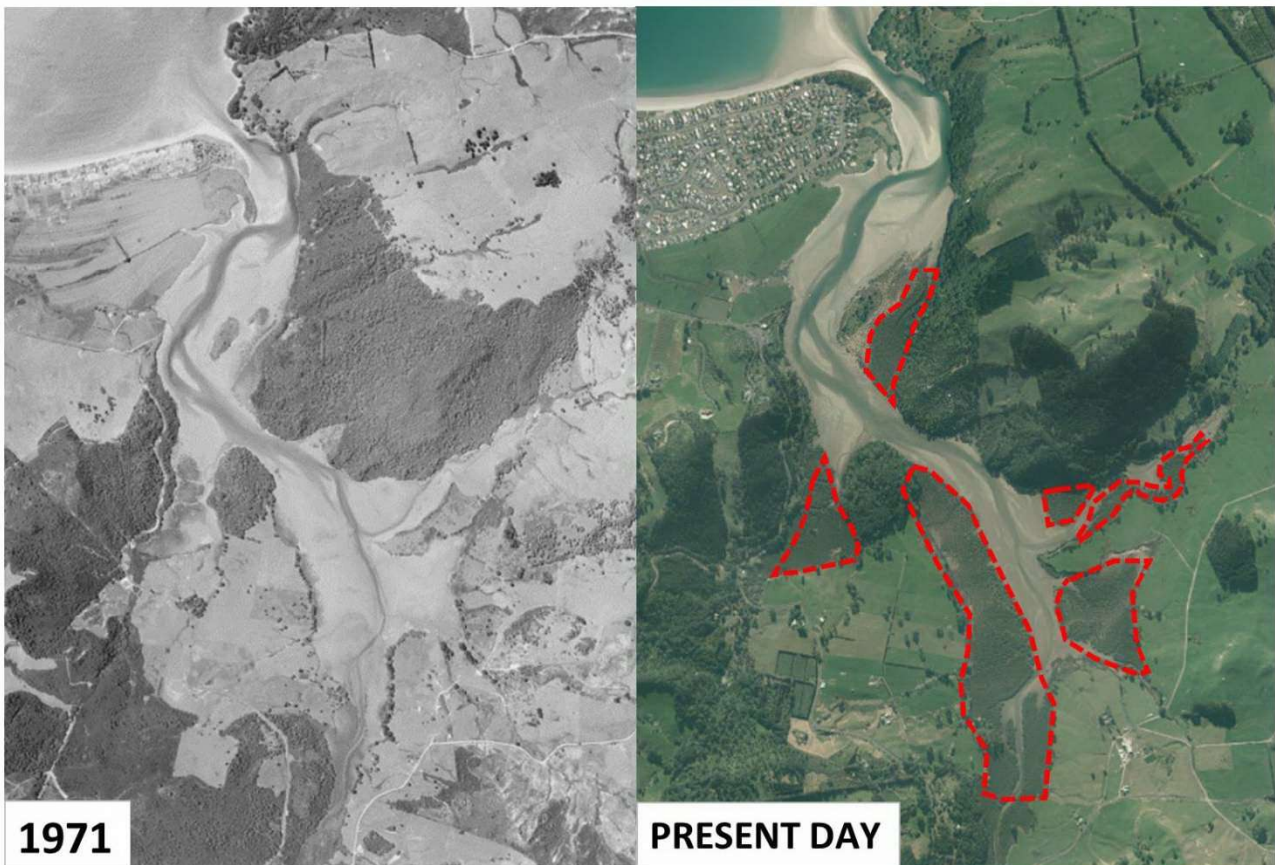
Figure 5: Mangrove colonisation in the Purangi Estuary since 1971 indicated by red dashed lines.

It was also noted that significant areas of mangrove colonisation have occurred post 1971 (**Figure 5** below). This is not uncommon across northern New Zealand and has been often attributed to land use changes and/or hydrodynamics changes to the system. At Cooks Beach it is mostly likely that land use change in the catchment and the limited accommodation space are the primary contributing factors. Whilst difficult to ascertain from aerial photography, sediment infilling is often associated with mangrove colonisation, which in turn can lead to a reduction in the tidal prism size. With a reduced tidal prism, the ebb tide flows and volumes are expected to have reduced which may in turn have contributed to the change in the form of the ebb tide delta noted above.

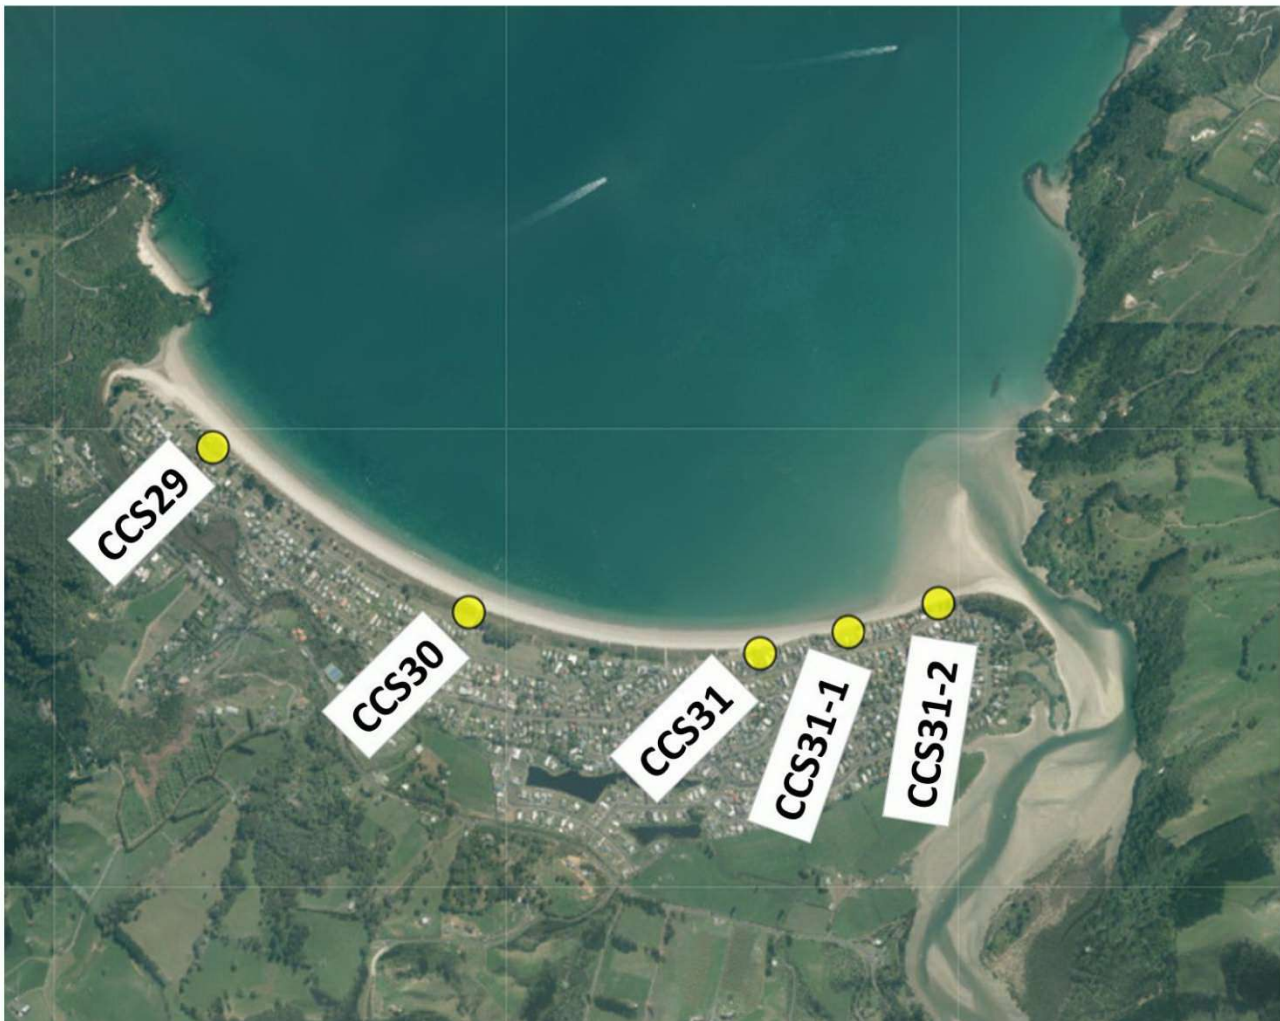
Figure 6: Location of beach monitoring profiles across Cooks Beach.

A high-level analysis of the beach monitoring sites along Cooks Beach has been undertaken using the Beach Morphology Analysis Package (BMAP). More detailed analysis here focused on Profile CCS31-2 (**Figure 6**) as this is situated in the area of concern. The other remaining profiles were briefly analysed for context of wider beach behaviour. **Figures 7 & 8** demonstrate the western end of the beach monitoring to have a mild accretionary trend in volumes above Mean Sea Level (MSL). However, due to the sparsity of early data points the analysis may be slight skewed and it is assumed over this part of the beach is a dynamic equilibrium.

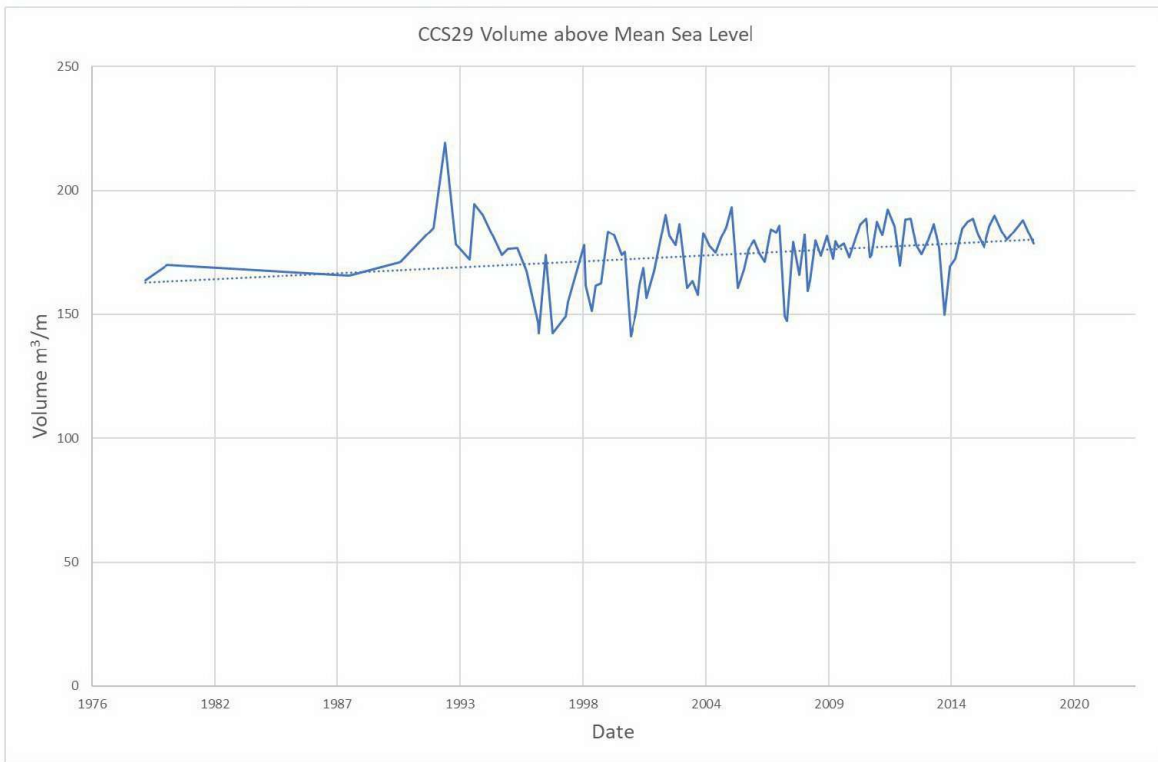
Figure 7: Beach monitoring data from the western end of Cooks Beach.

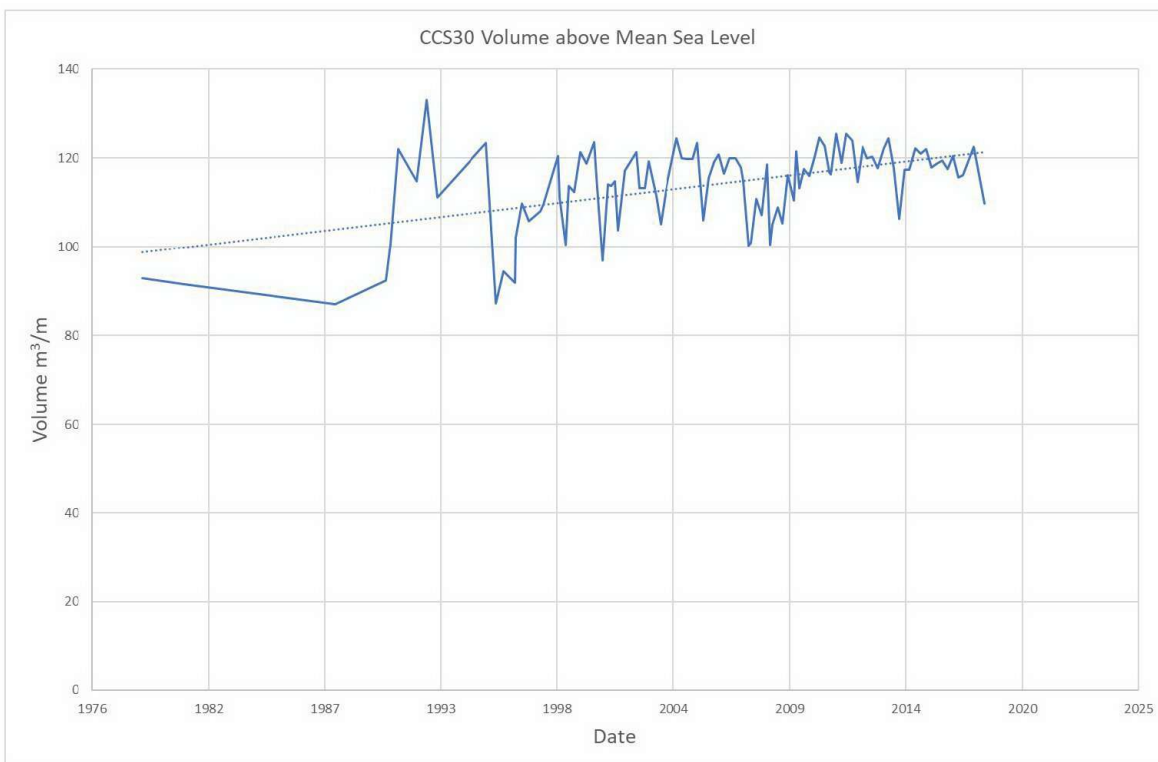
Figure 8: Beach monitoring data from the central portion of Cooks Beach.

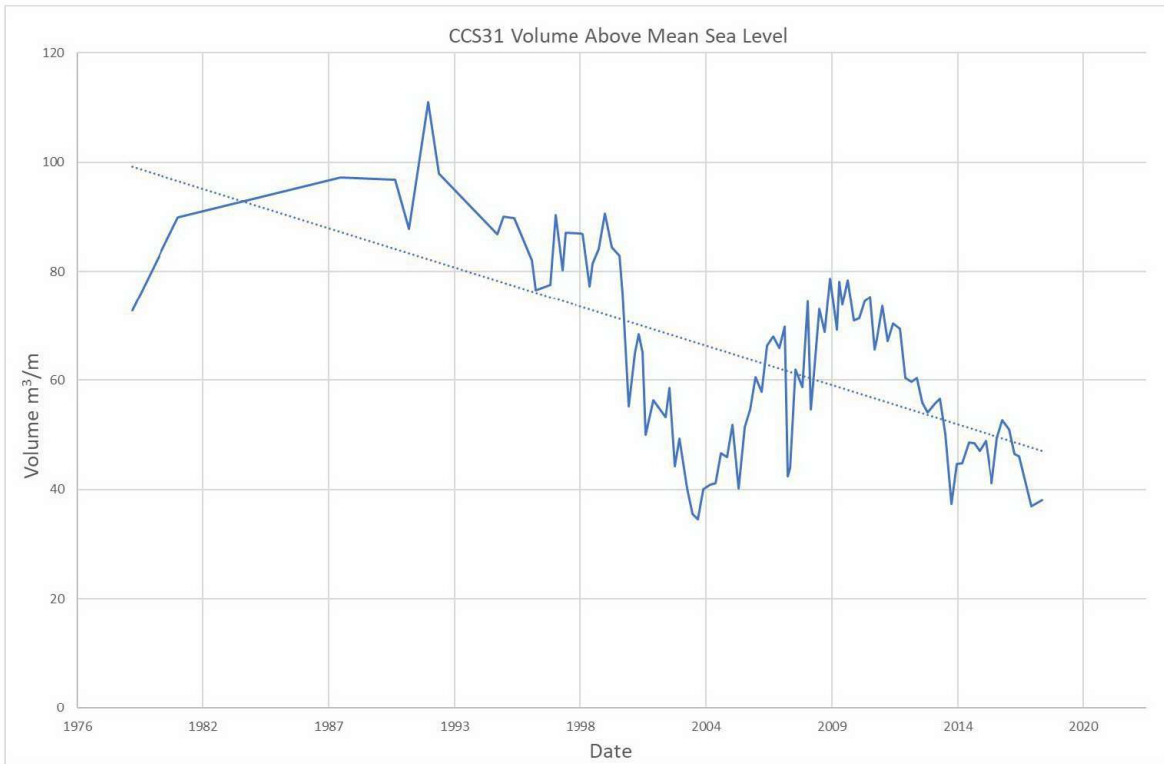
Figure 9: Beach monitoring data from the near-eastern end of Cooks Beach.

Data from profile CCS31 illustrates a reasonable strong erosion trend with an estimated 30% loss of material above MSL over the 40-year monitoring period (**Figure 9**). However, the position of the dune has not retreated to the same extent and this is thought to be related to the stability afforded by the dune planting cells. The erosion trend is not as strong in profile CCS31-1 (**Figure 10**), but this is thought to be related to the degree of modification that has occurred and eventual construction of a revetment seawall. Greater detail about the nature of the modifications may provide an insight to the nature of the beach behaviour at this monitoring point but for the purpose of this assessment it has been assumed that

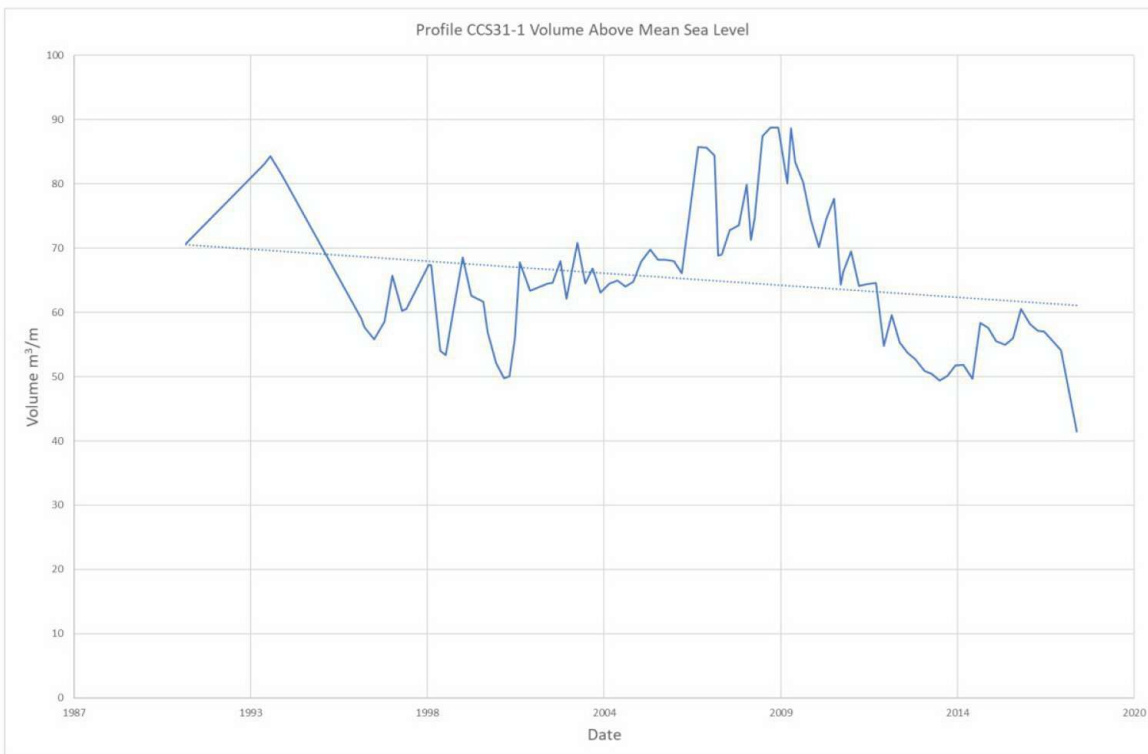
Figure 10: Beach monitoring data from the mid-eastern end of Cooks Beach.

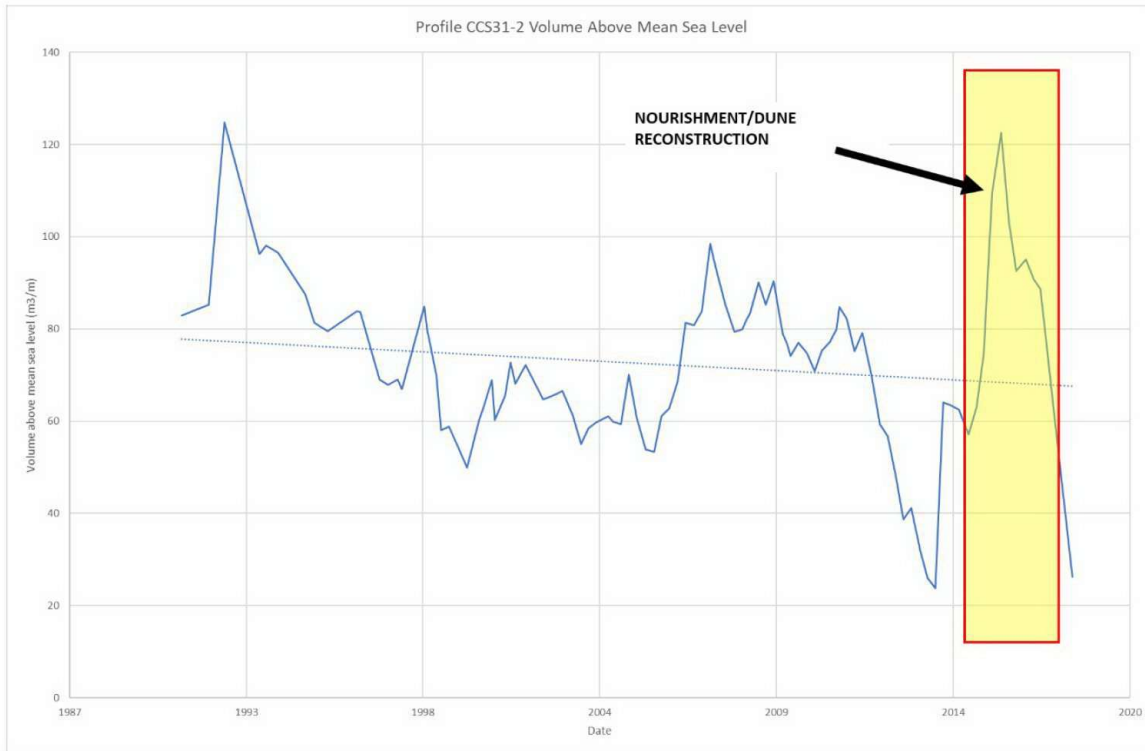
Figure 11: Beach monitoring data from the far-eastern end of Cooks Beach.

Similarly, the data from CCS31-2 shows a weaker erosion trend (**Figure 11**) but this is thought to be the result of site modifications such as the nourishment and dune reconstruction works in 2016 artificially accreting the profile.

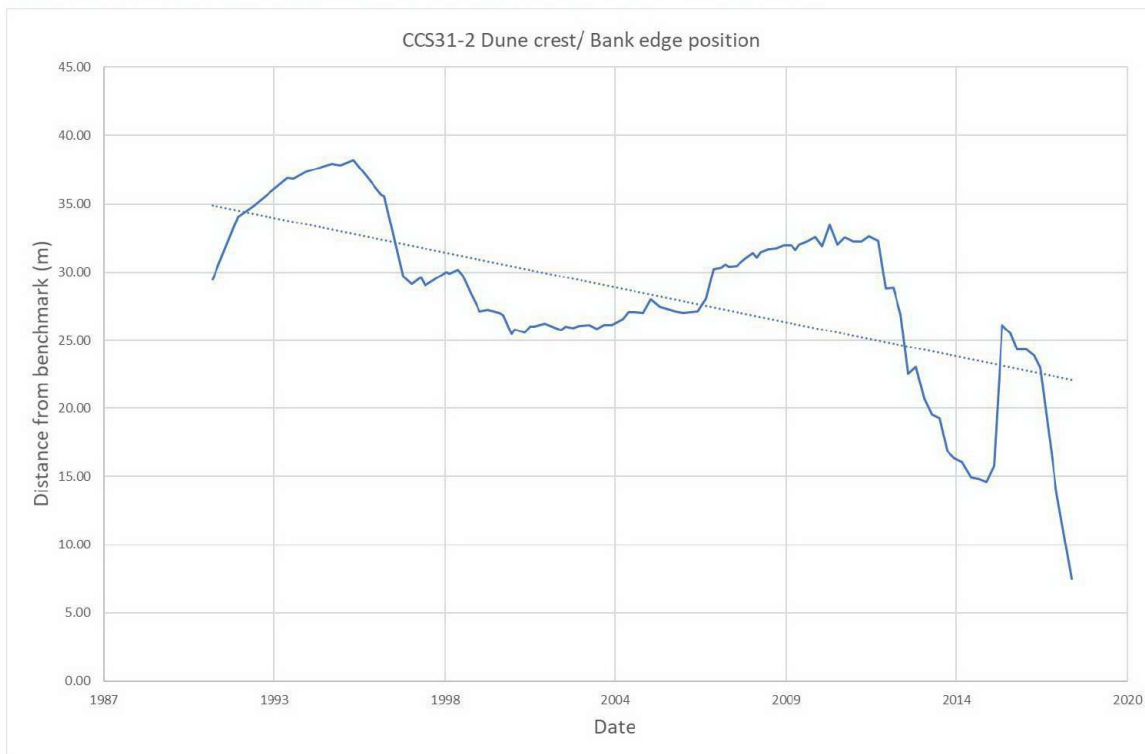
Figure 12: Migration of dune crest / bank edge from datum point at far-eastern end of Cooks Beach

The position of the RL2.5m contour relative to the bench mark has been used as a proxy for the dune crest/bank position. Despite modifications and nourishment works at CCS31-2, this part of the beach system the dune crest has retreated approximately 20m over the past 27 years (**Figure 12**).

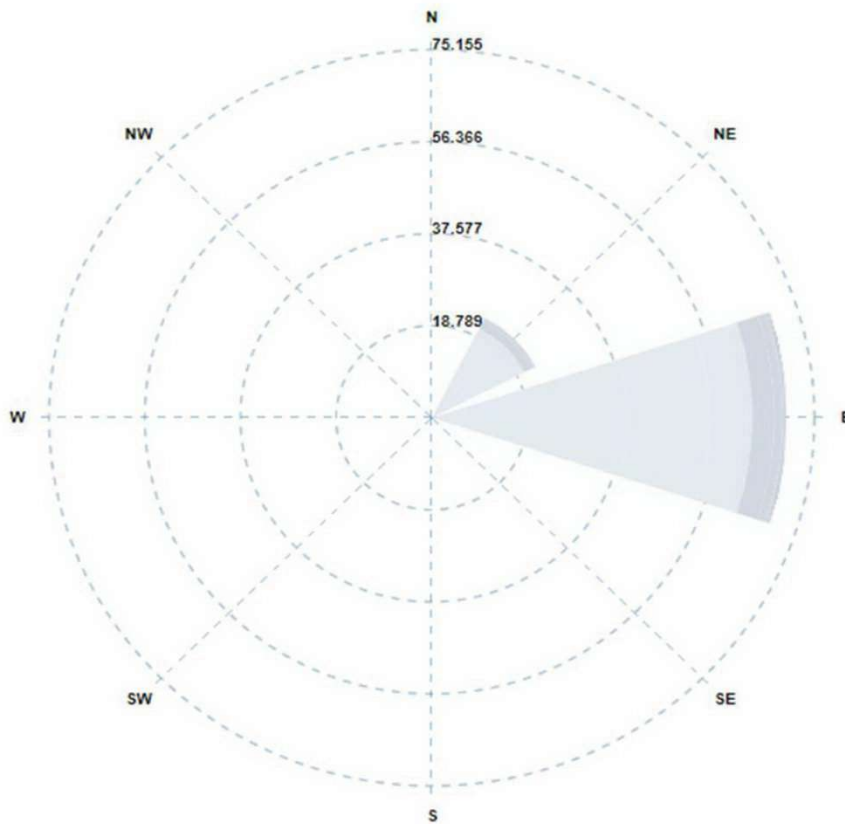
Figure 13: Offshore wave rose data for the subject site².

The site is generally orientated east to west and therefore exposed to waves from the northwest to the northeast. Due to the limited fetch from the northwest and the north due to landmasses, it is considered that the largest waves approaching the beach are generally from the northeast either as wind generated storm events or open ocean swells refracting into the bay. Large east swell events are also thought to reach the site after similarly refracting around Cooks Bluff. **Figure 13** below shows the wave rose from the nearest offshore modelling location, and **Figure 14** provides the extreme offshore wave heights. In general, waves operating at the beach during storm and/or swell events will be in the range of 0.5-2m.
